EVALUATION OF SEATING AND RESTRAINT SYSTEMS
AND ANTHROPOMORPHIC DUMMIES
CONDUCTED DURING FISCAL YEAR 1976

10 Richard F. Chandler
Edwin M. Trout

FAA Civil Aeromedical Institute
Oklahoma City, Oklahoma

11 February 1978

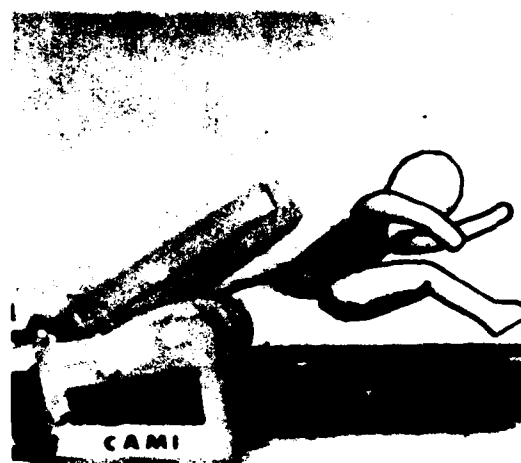
Figure 4. Dynamic Crash Test.
Sequence taken from high-speed film.

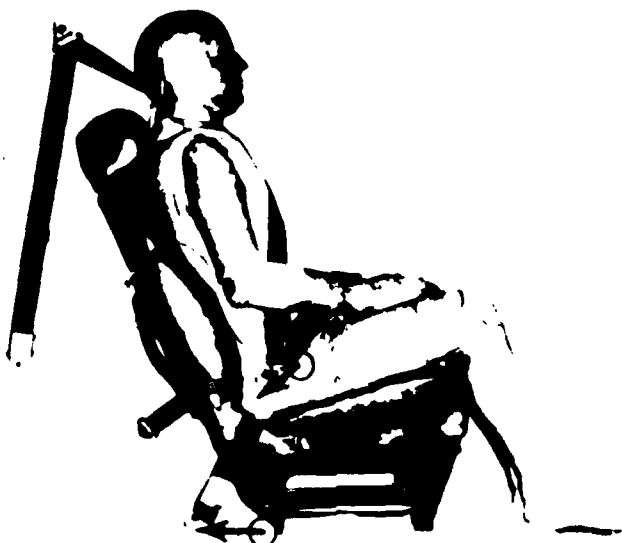
Figure 8. Modifications to restraint included relocation of buckle to the side of the hip and movement of inboard anchorage point to the rear. Initial locations are shown by circles.

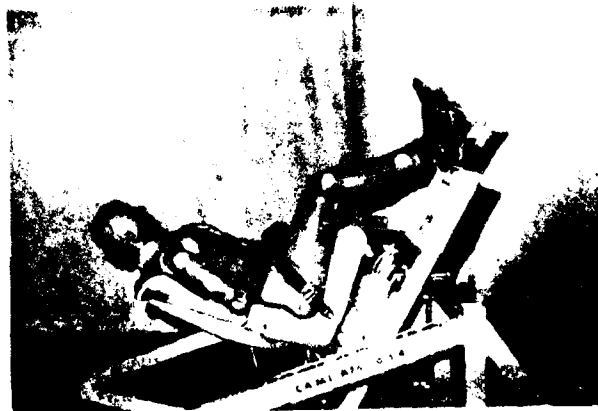
Figure 16. Helicopter seat after test. The energy-absorption system has stroked.

Three seat orientations were tested, so that data were obtained under vertical impact (Figure 15), with the impact vector oriented 60° below the horizontal (Figure 16), and with the impact vector horizontal and 15° to the left (Figure 17). Principal data obtained in the tests are summarized in Table 6.

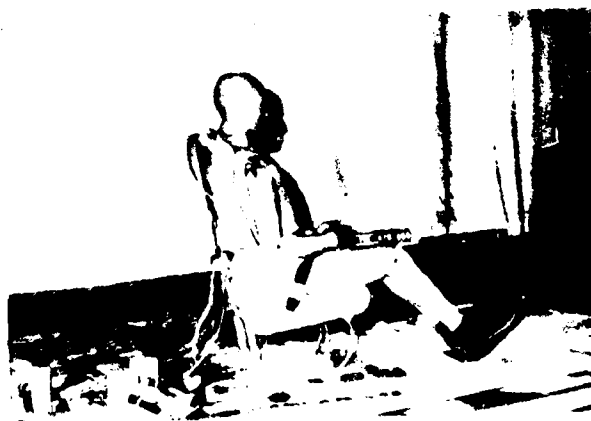
Figure 17. Helicopter seat before test.

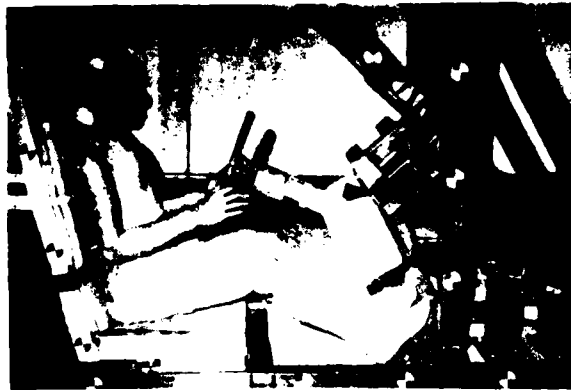
Figure 18.

This program was conducted to evaluate the performance of automotive-type energy-absorbing steering column assemblies so that the feasibility of their use as aircraft control columns could be determined. Initial static testing on the columns indicated that the columns stroked at between 350 and 500 lb of force when loaded axially. Initial dynamic tests positioned the column in a conventional automobile configuration and used an unrestrained anthropomorphic dummy (Figure 18). Crushable knee bolsters provided a contact surface to prevent knee damage. It was found that the column would "lock" because of the eccentric load application and transmit up to 2,400 lb of force with minimal column stroke. Efforts to increase the bearing area and alleviate locking conditions on the column were of little improvement, increasing the stroke displacement only from 1 in to 4 in. The fourth, fifth, and sixth tests used a dummy with lapbelt so that the chest contacted the column in a manner more conducive to producing axial loads. Although the column stroke increased to more than 7 in, peak chest decelerations were not significantly reduced. Data are shown in Table 7. It was concluded that the energy-absorbing steering column is sensitive to eccentric loading and would require further development to eliminate this sensitivity before consideration of aircraft application is warranted.
